HOLY FAMILY CATHOLIC CHURCH

Structural Analysis of Church Building

316 South Logan Street
Lincoln, Illinois

Final Report

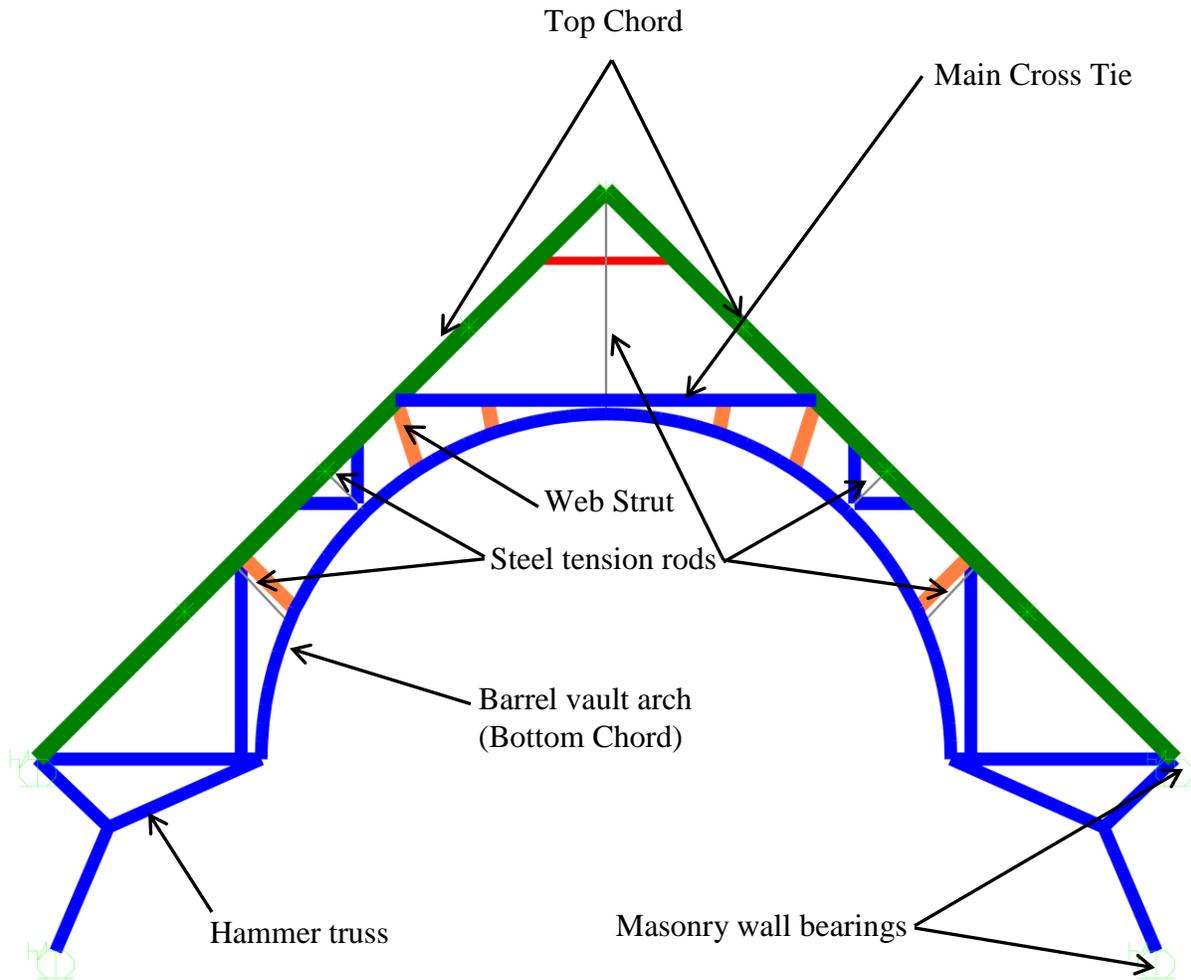
Figure 1. Rendering of typical truss illustrating arrangement of primary members and features of construction.

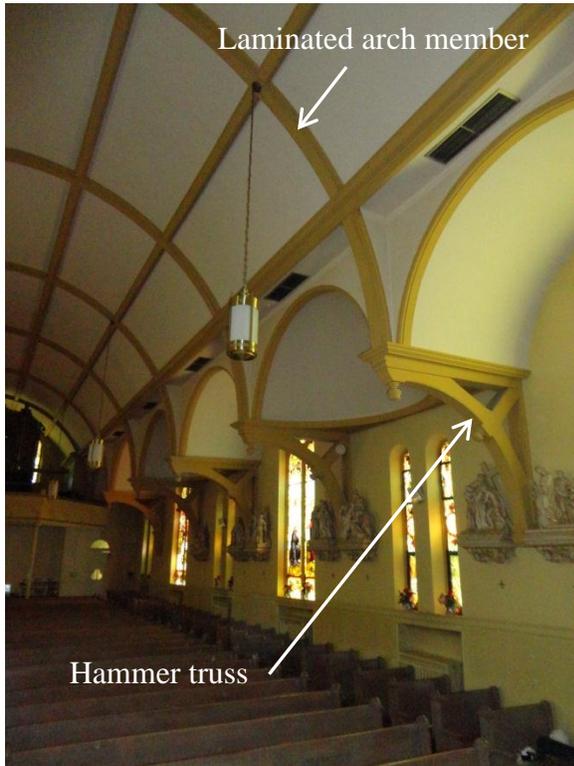
Figure 2. Interior of sanctuary showing main barrel vault arch members bearing on hammer truss.

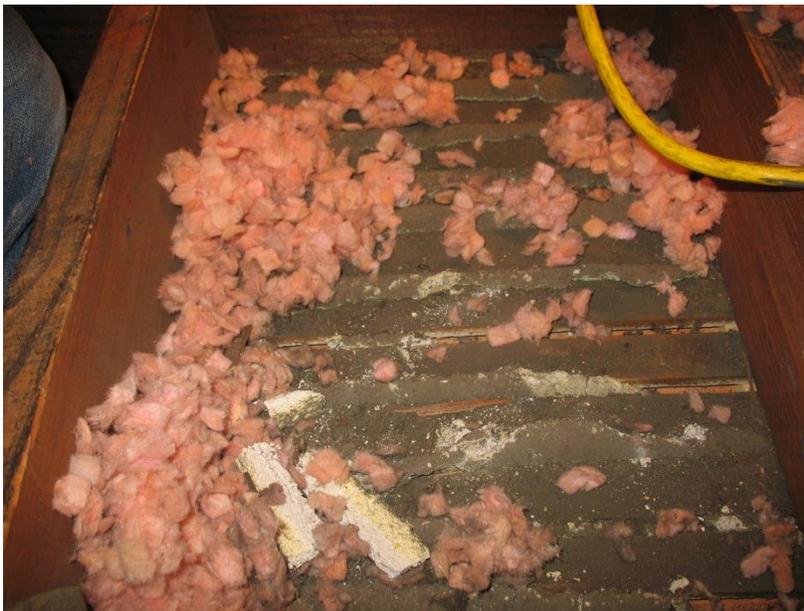
- Much of the original plaster of the barrel vault ceiling was concealed, but appears to have remained in place behind the plywood finish installed during a recent renovation project. (Figure 3).

Figure 3. Original lath and plaster largely intact beneath insulation; plywood infill appears to have been installed over top of existing plaster.

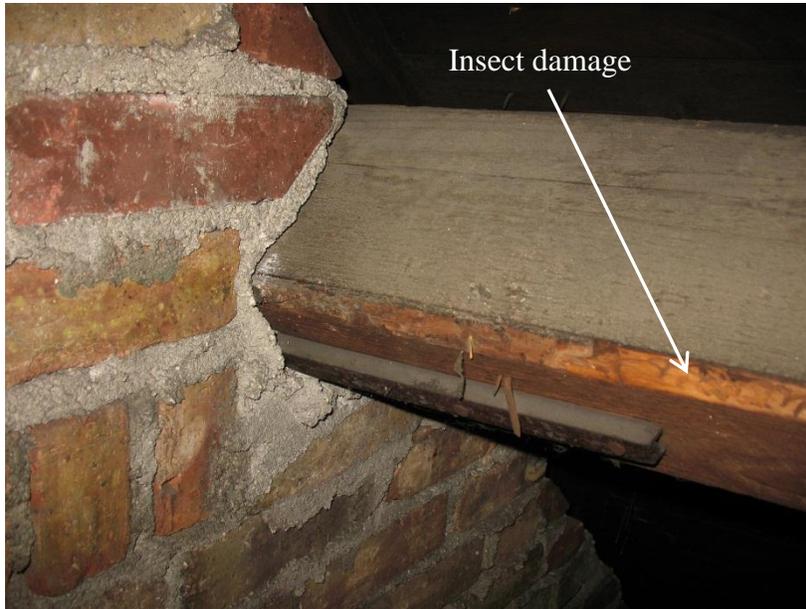
- Moisture staining was observed at a purlin bearing location along the east sanctuary wall with some minor insect damage (Figure 4 and 4a). This damage was not deemed structurally significant.

Figure 4. Insect damage visible on corner of purlin near bearing at east wall of sanctuary; not structurally significant.

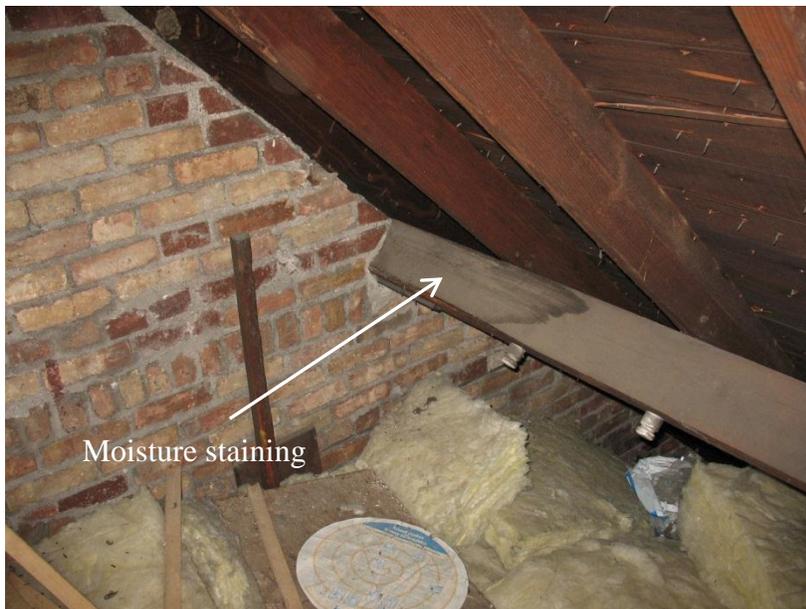
Figure 4a. Another view of the purlin bearing at east wall of sanctuary showing extent of moisture related staining. No significant wood decay was observed.

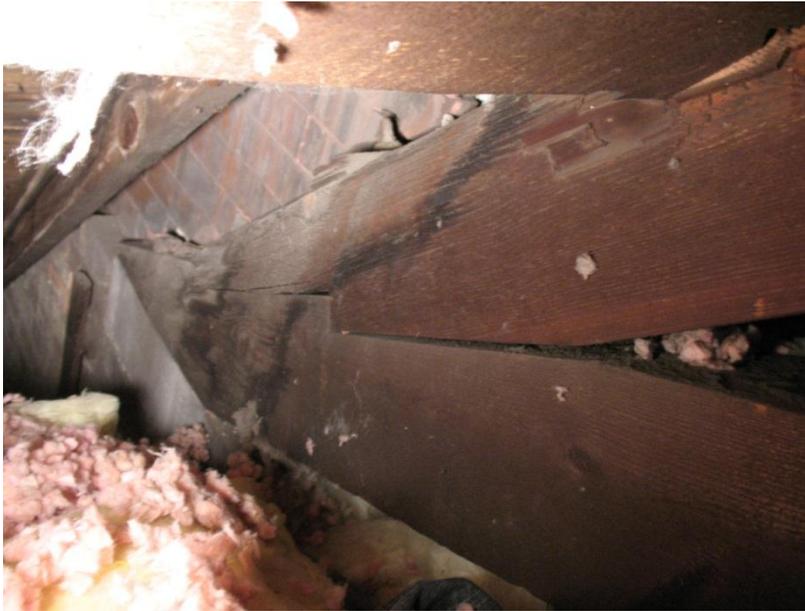
- Moisture and staining were observed at the south bearing of the choir loft truss (Figure 5), but no structurally significant deterioration of the wood was found.

Figure 5. South bearing of choir loft truss on interior masonry wall. Note moisture staining; no deterioration observed.

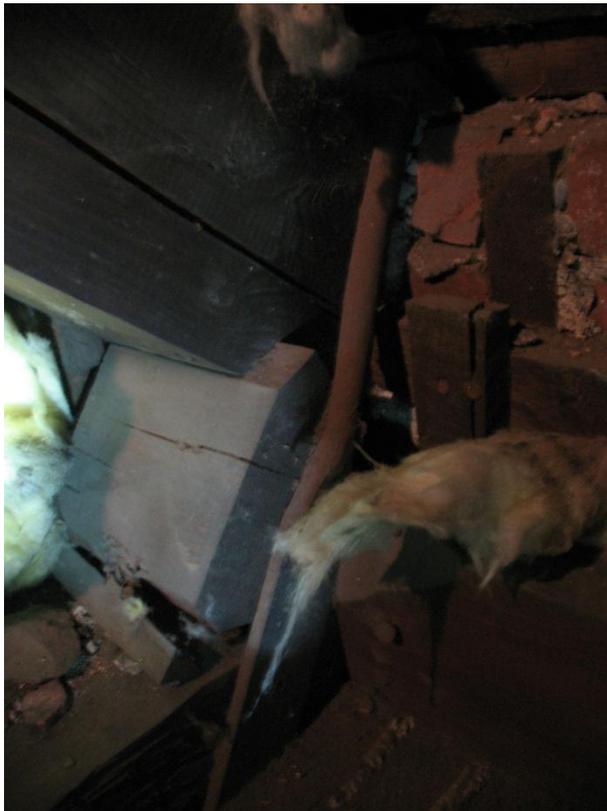
- The bearing areas of the typical main truss top chords and hammer truss top chords on the masonry wall were largely encased in masonry (Figure 6). Accordingly, WJE could not assess whether deterioration was occurring at these locations. Visible portions of the bearing locations did not exhibit any obvious signs of distress.

Figure 6. Typical truss bearing at exterior masonry wall (at buttress). Actual bearing condition concealed by masonry beyond steel connection tie in foreground.

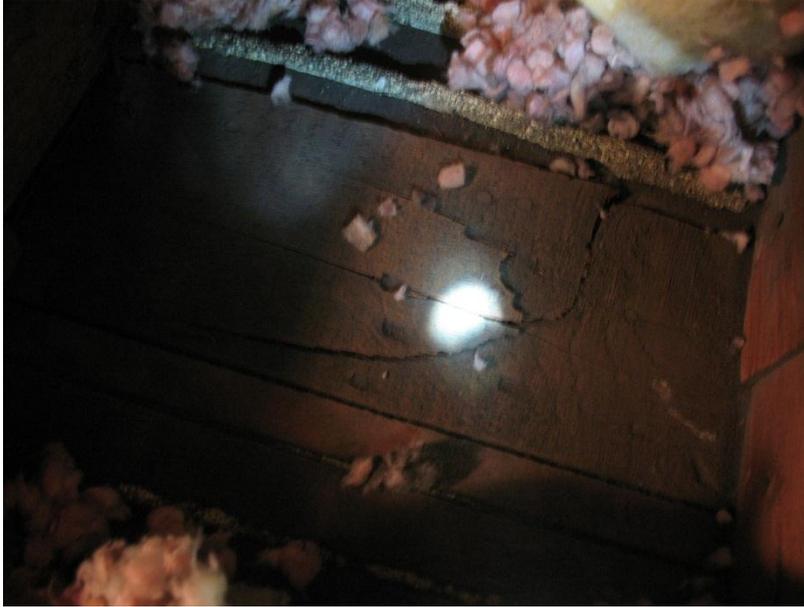
- WJE observed a partial fracture on the top face of one of the main barrel vault built-up arch members at a typical truss (Figure 7). This was observed near the top of the arch, just south of the center of the truss, north of the first compression web strut.

Figure 7. Partial fracture of built-up main arch member of barrel vault in typical truss.

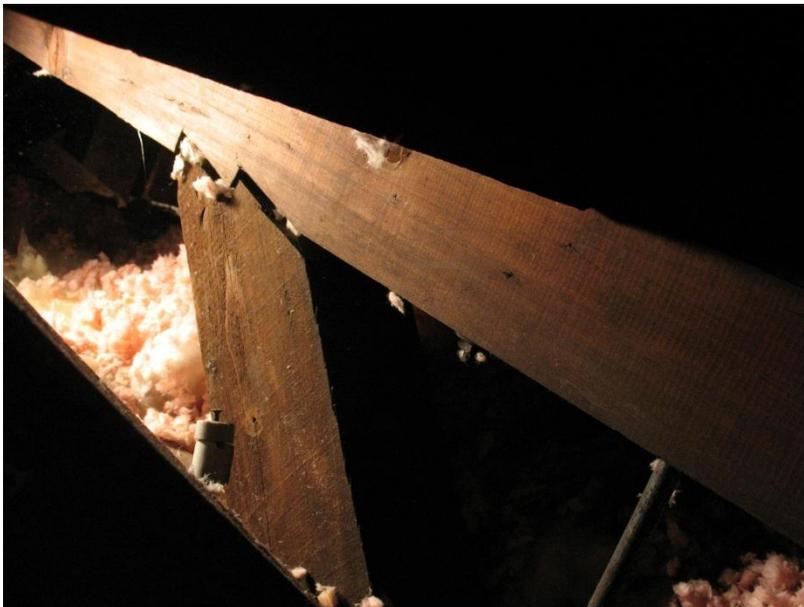
- Numerous compression struts exhibited partial pull-out of their toe-nailed connections, especially near the center of the typical truss (Figures 8 and 9).

Figure 8. Example of disengaged compression web member connection (double bird's mouth) on typical main truss consistent with downward displacement of the arch and spreading of the top chords.

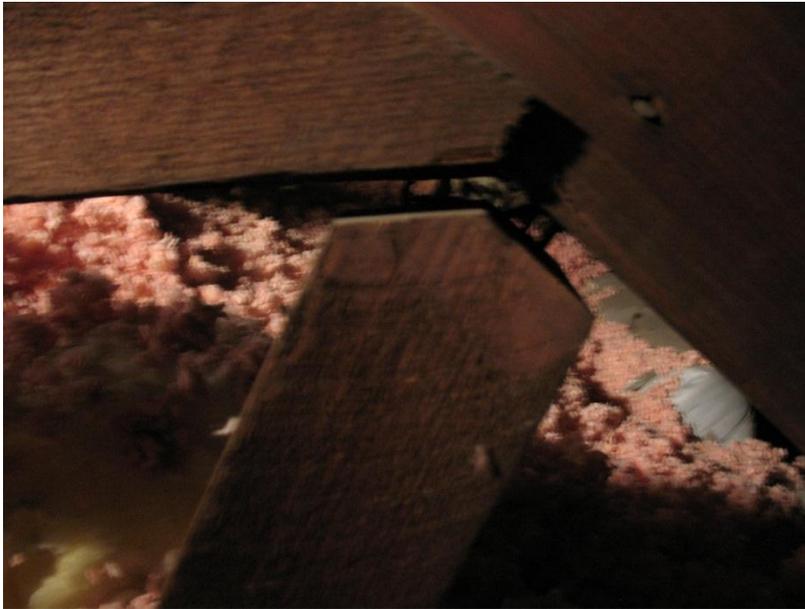
Figure 9. Another example of a typical truss compression strut with toe-nailed connection partially pulled-out.

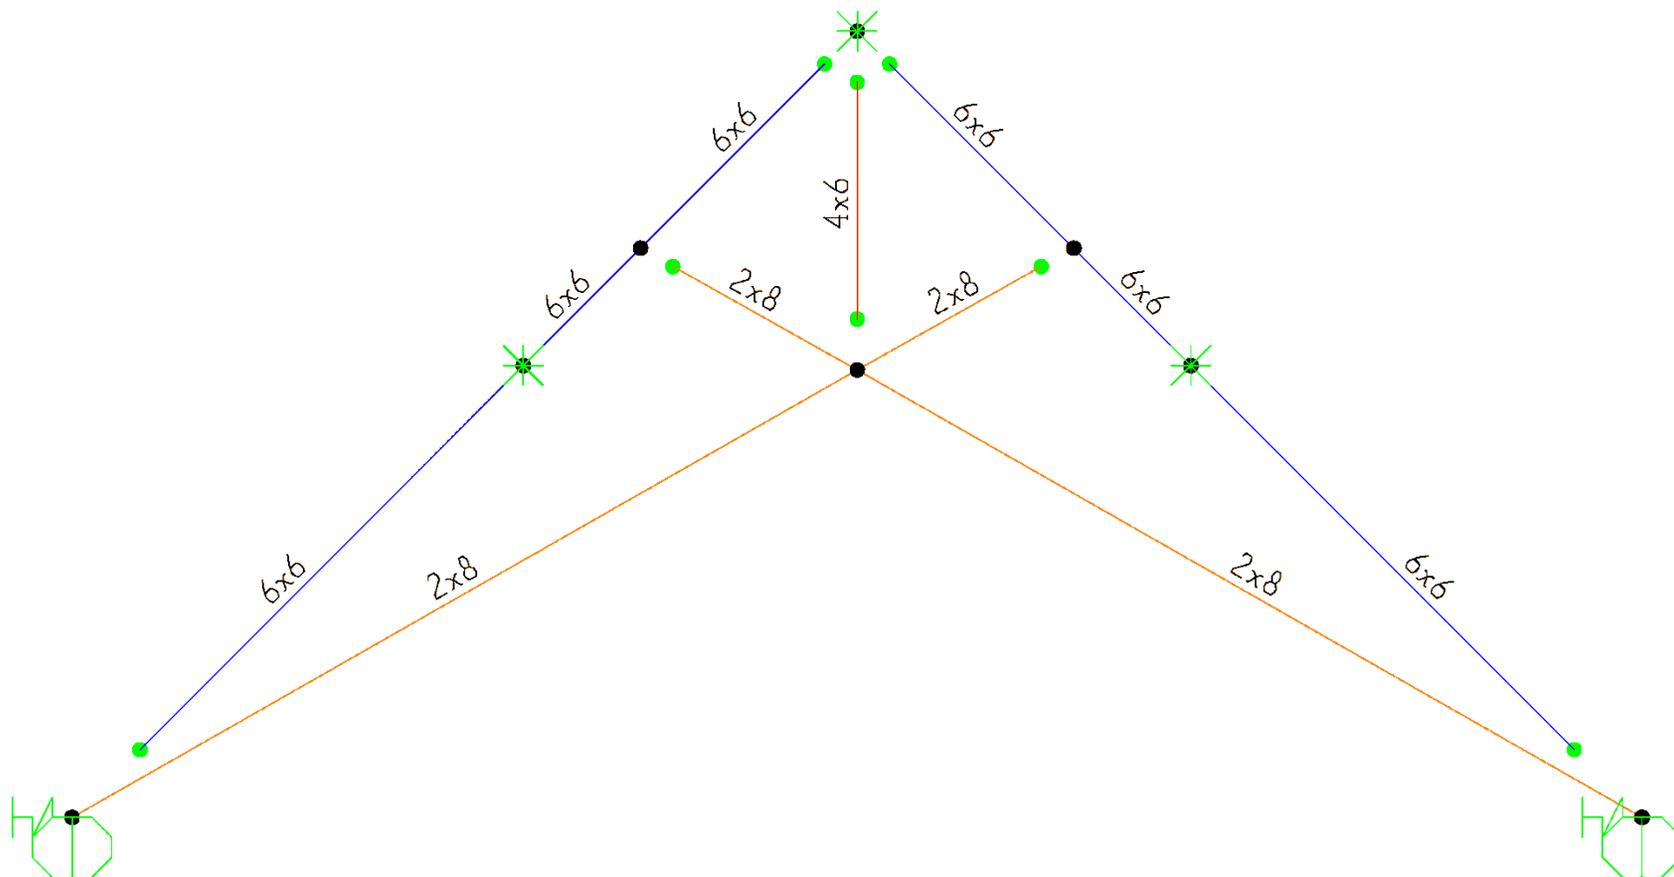
Figure 10. Finite element model of altar truss indicating member sizes.

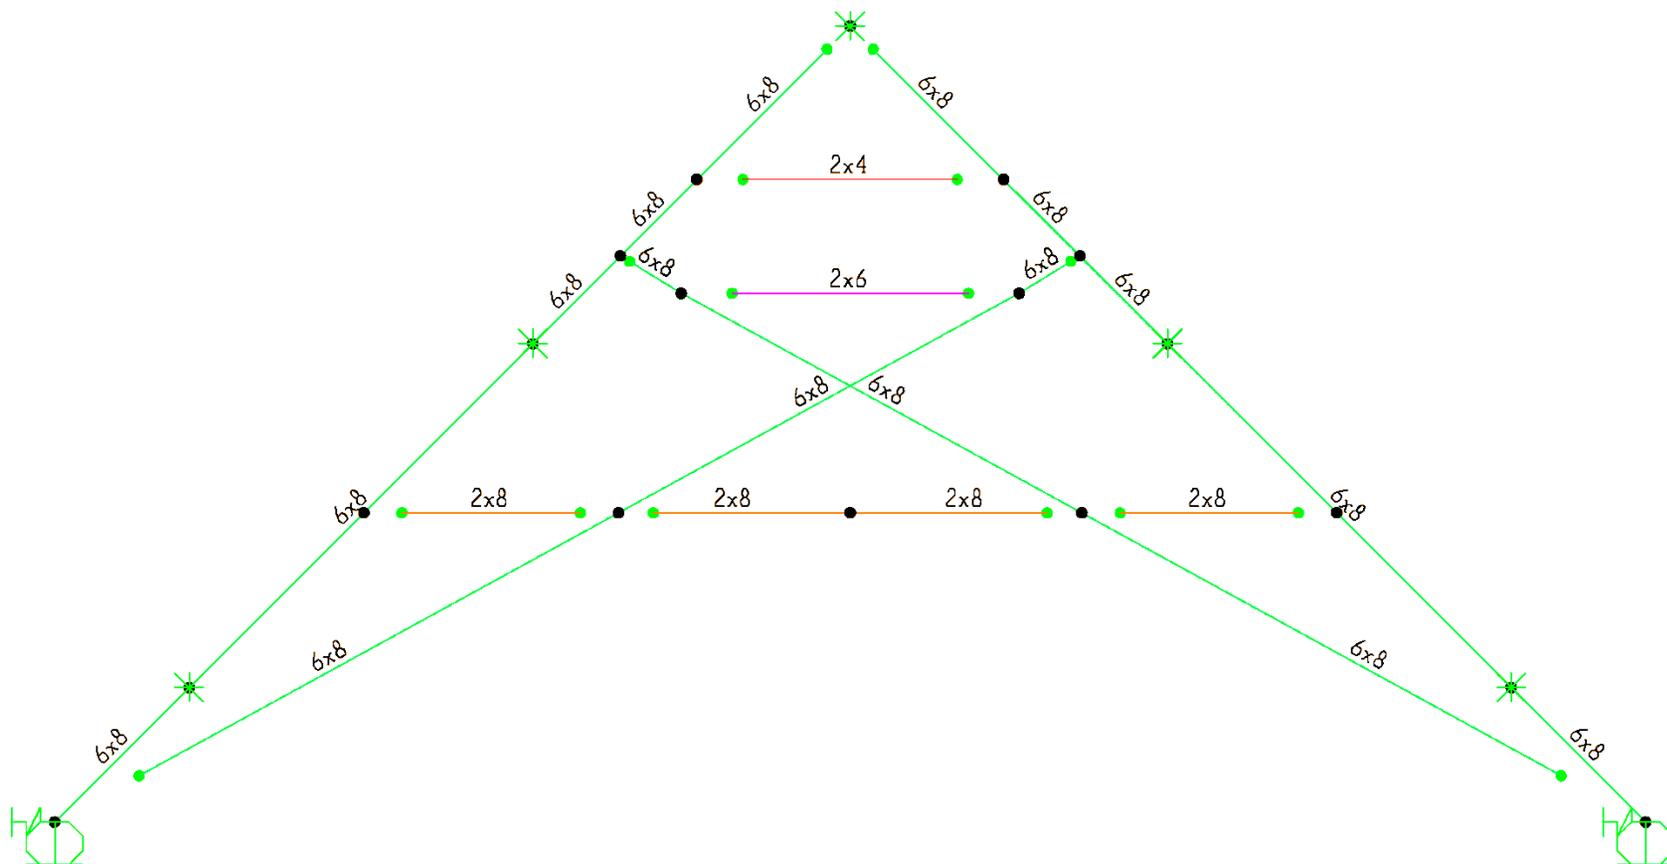
Figure 11. Finite element model of choir loft truss indicating member sizes.

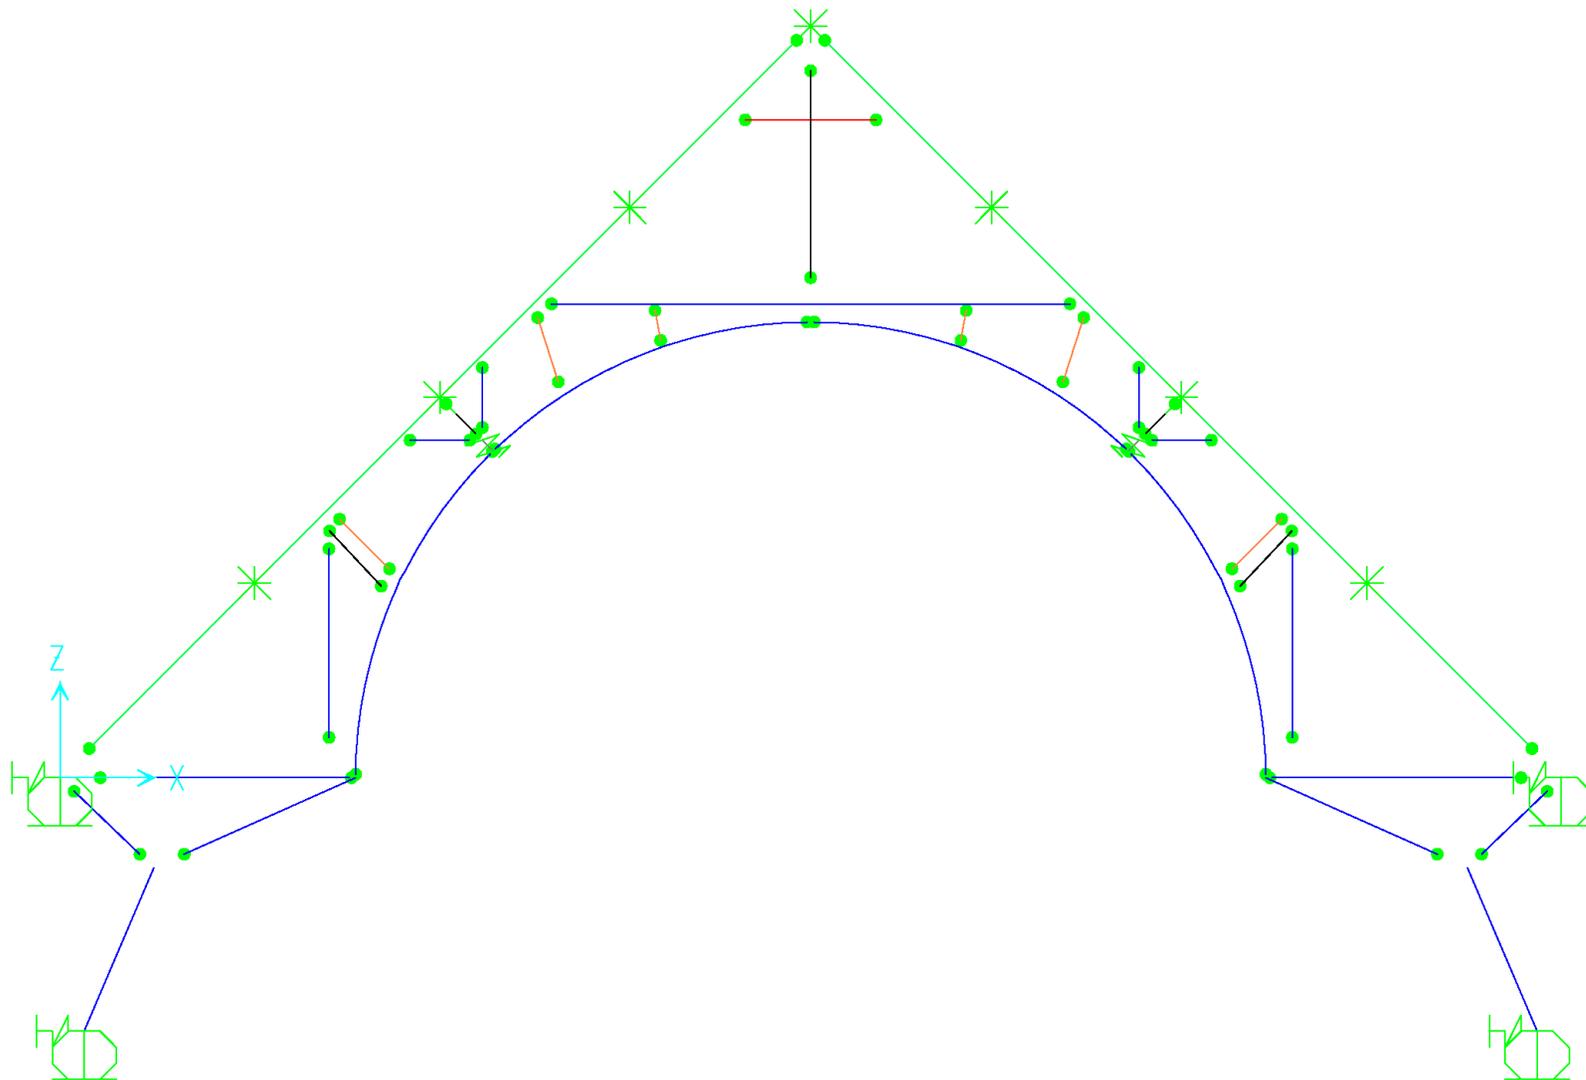
Figure 12. Finite element model of typical truss. Note: Blue members are 6x6 timbers, green members are 6x8 timbers, orange members are 4x6 lumber, red top cross tie is a 2x4, and black members are steel tie rods.

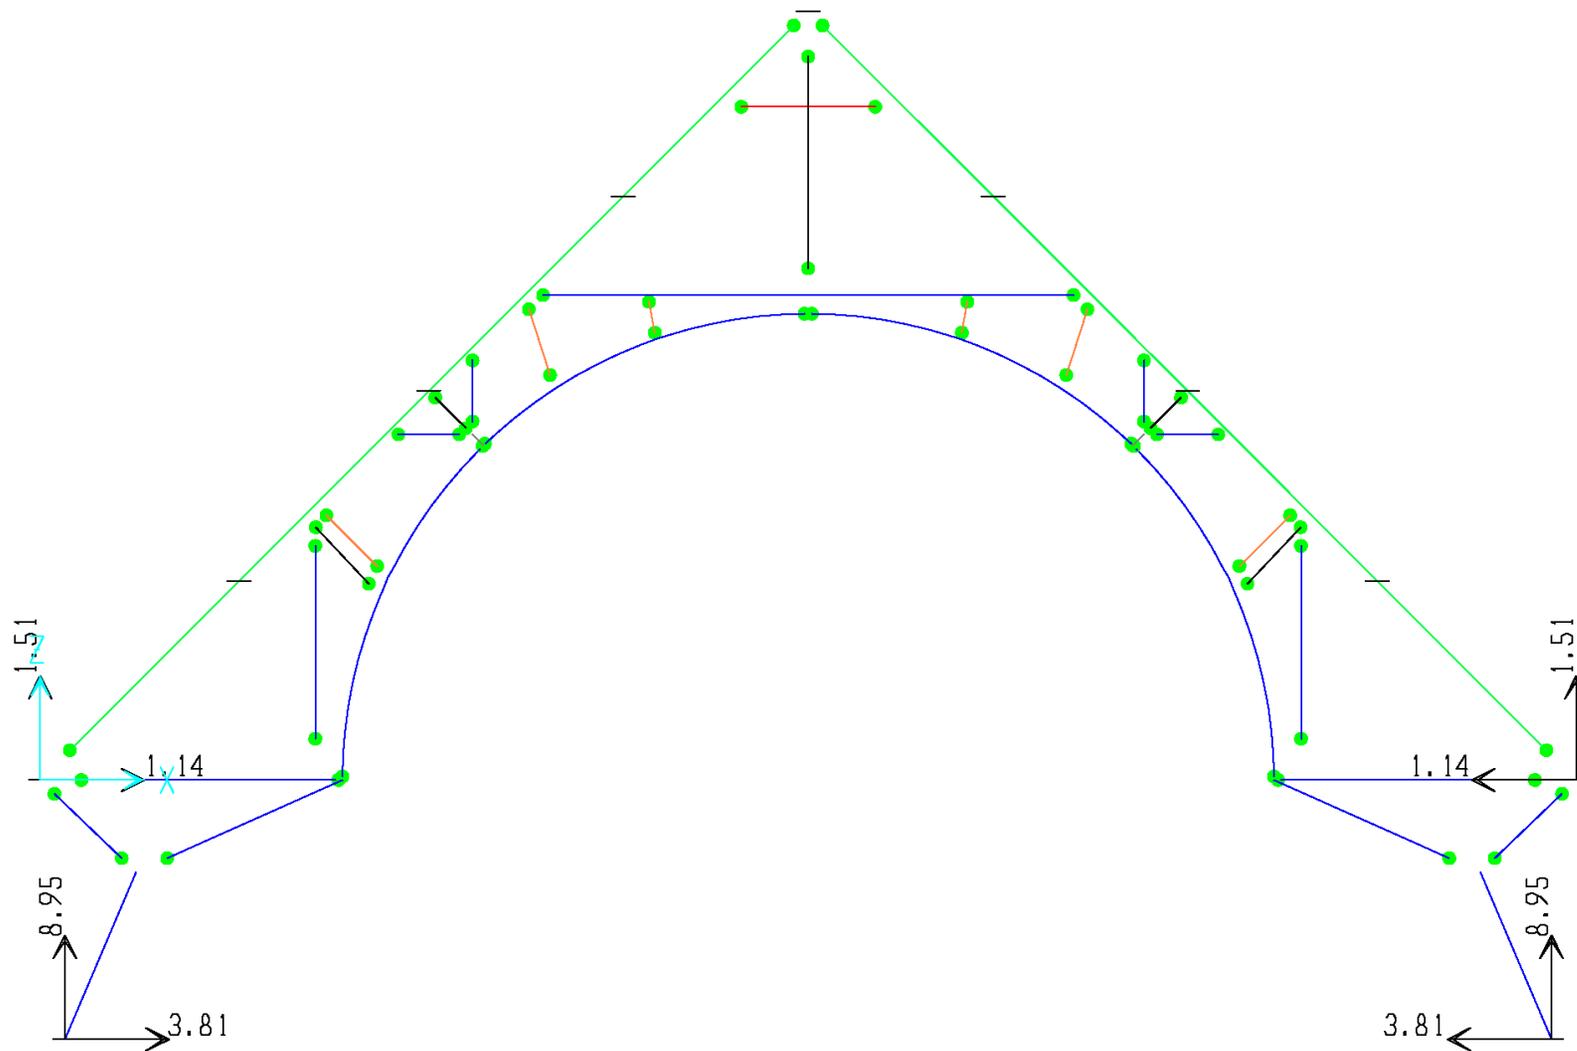
Figure 13. Typical truss force reactions on masonry walls under dead load (self-weight), in kips. Note: 1 kip = 1000 pounds. Indicative of the level of arch action and resistive thrust provided by the masonry buttresses.

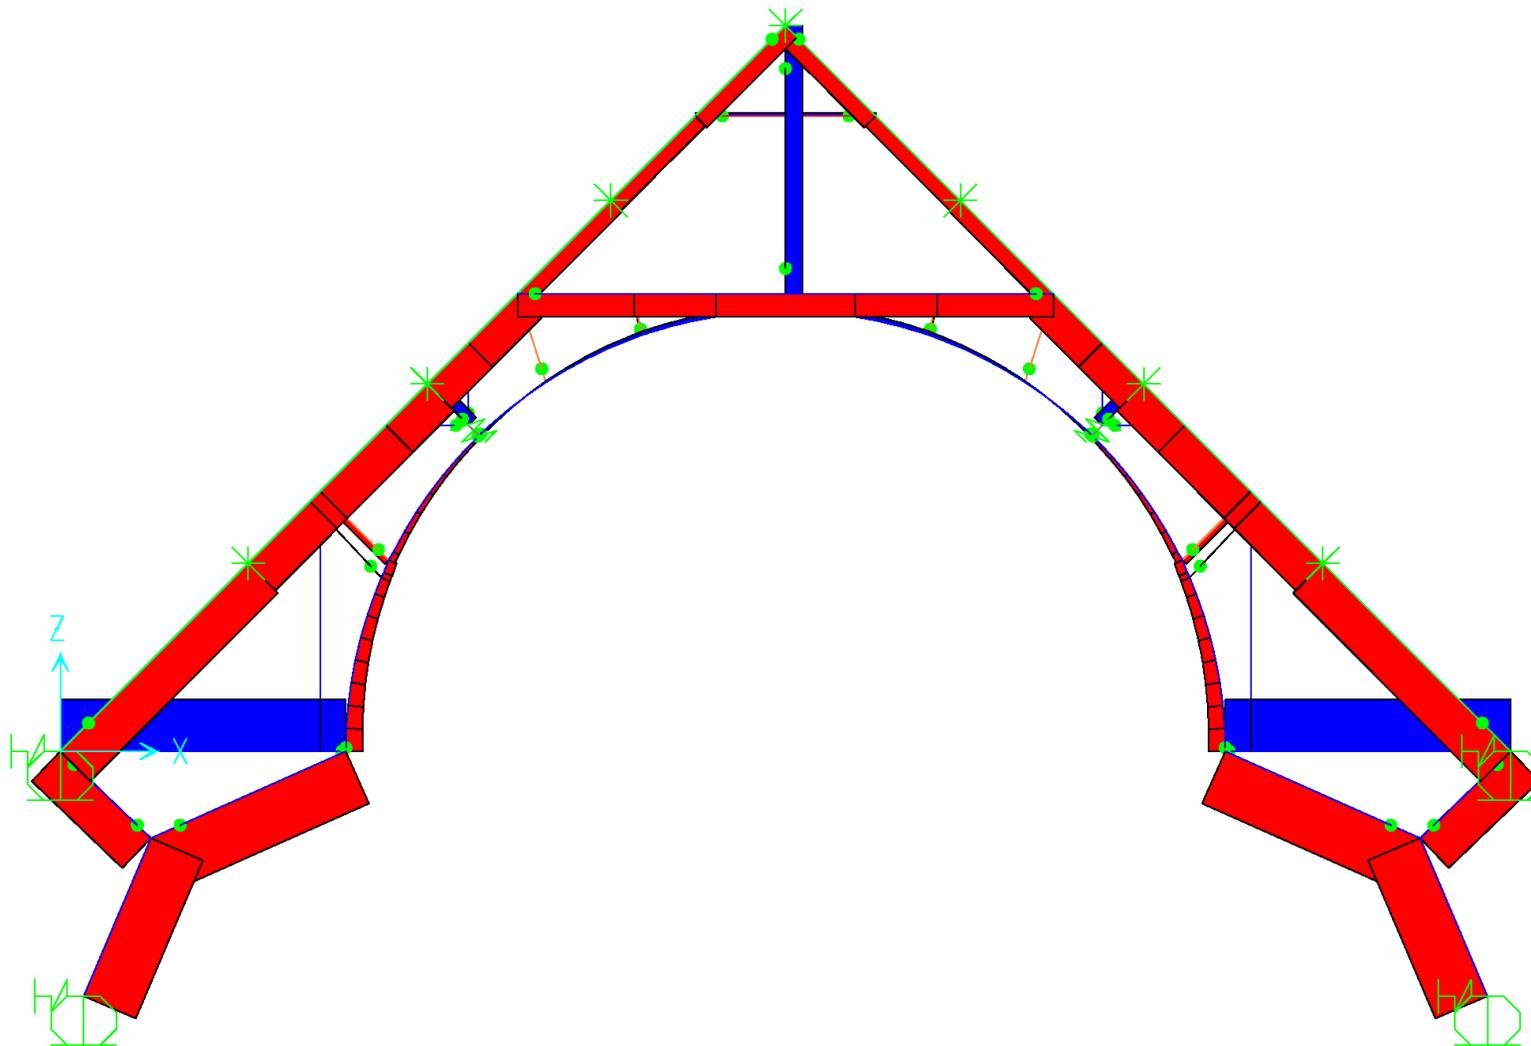
Figure 14. Typical truss diagram showing member axial force results under dead load; force results are to scale. Blue indicates tension, red indicates compressive force. Note: Maximum force shown is in hammer truss bottom chord = 10,000 pounds. Axial forces are indicative of truss and arch structural behavior.

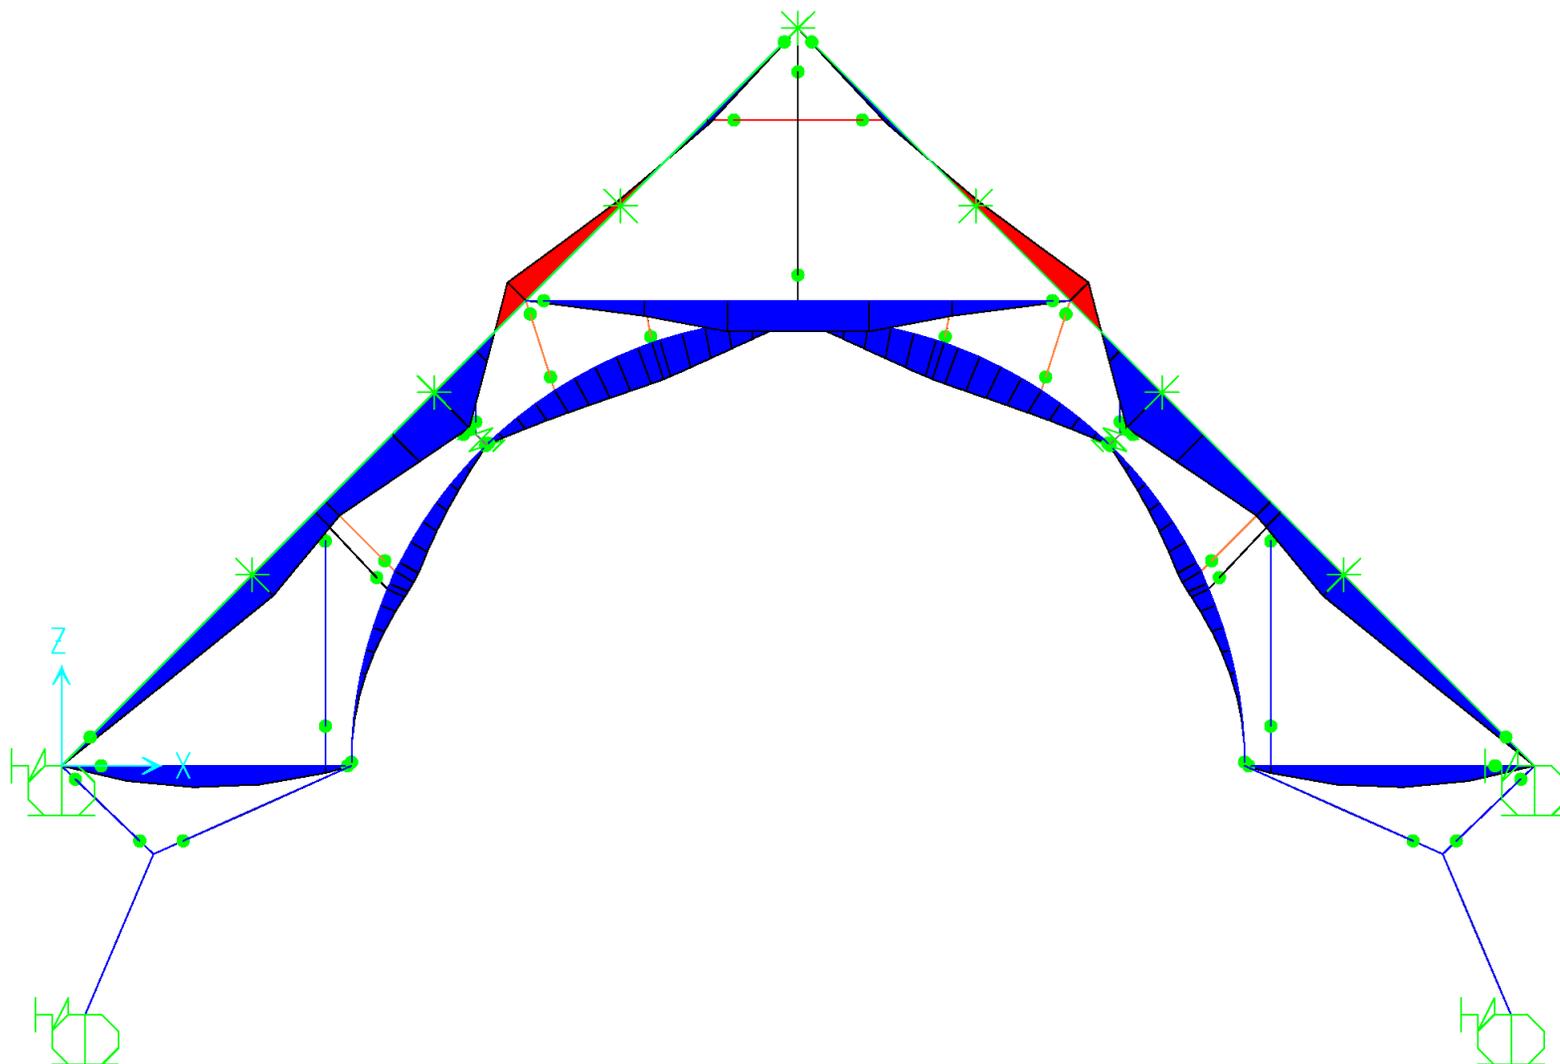
Figure 15. Typical truss diagram showing member bending load (beam action) results under dead load; results are to scale. Blue indicates downward bending, red indicates upward bending relative to the member orientation. Note: Maximum bending in top chord is about 4,500 ft-lbs.

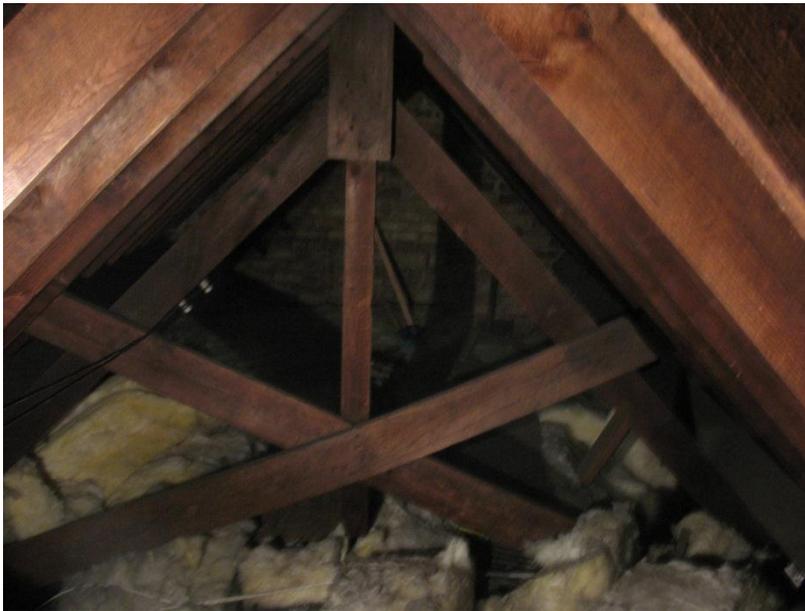
Figure 16. View of altar truss showing face nailed connections throughout.
