HOLY FAMILY CATHOLIC CHURCH Limited Condition Assessment

**316 South Logan Street
Lincoln, Illinois**

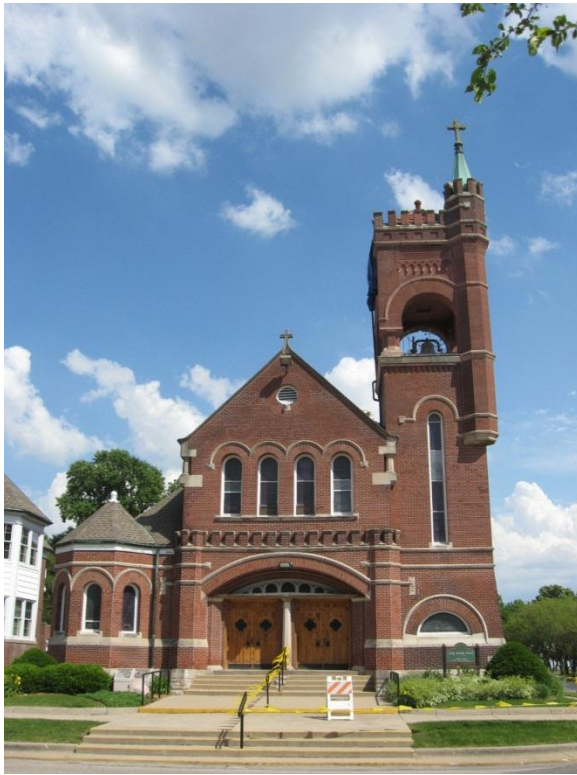
Figure 1. Overall view, west elevation.

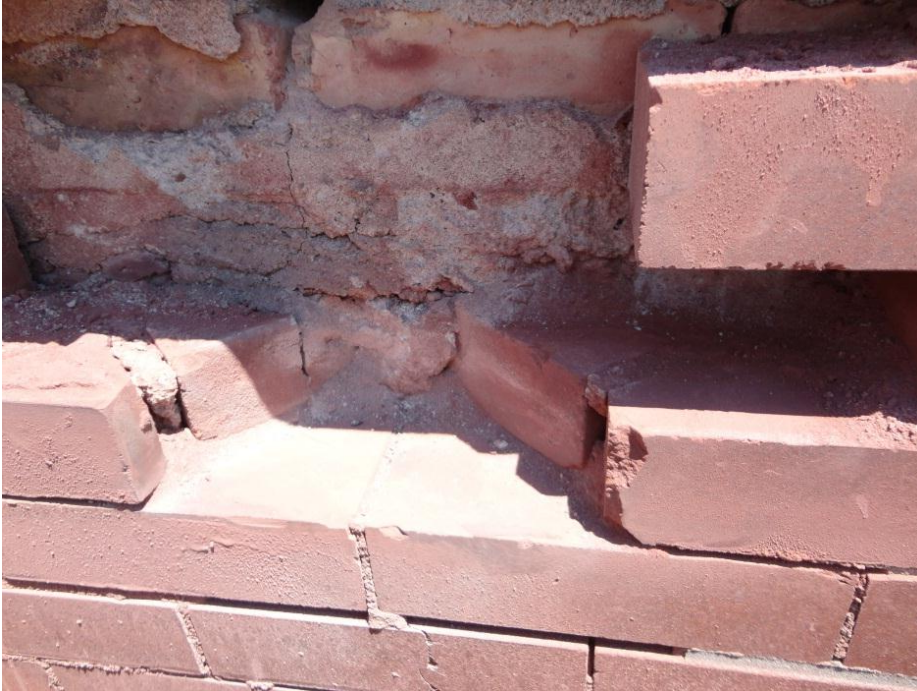
Figure 7. Notch-cut brick construction, as observed in the inspection opening on the east elevation of the lower bell tower.

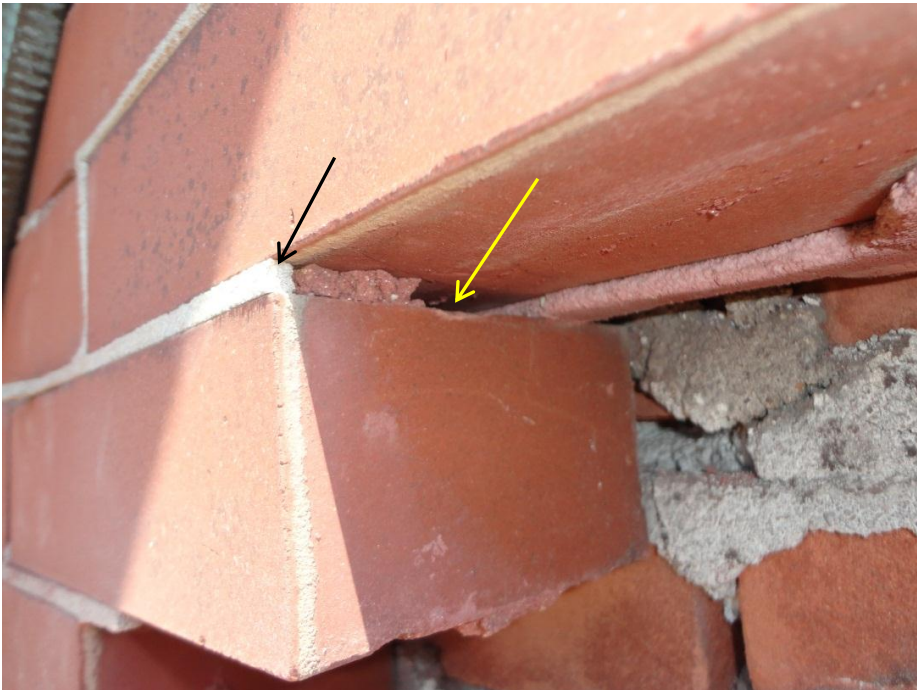
Figure 8. South elevation gable inspection opening showing the middle void between the original veneer mortar joints (yellow arrow), along with the lighter colored skim repointing failing near the opening (black arrow).

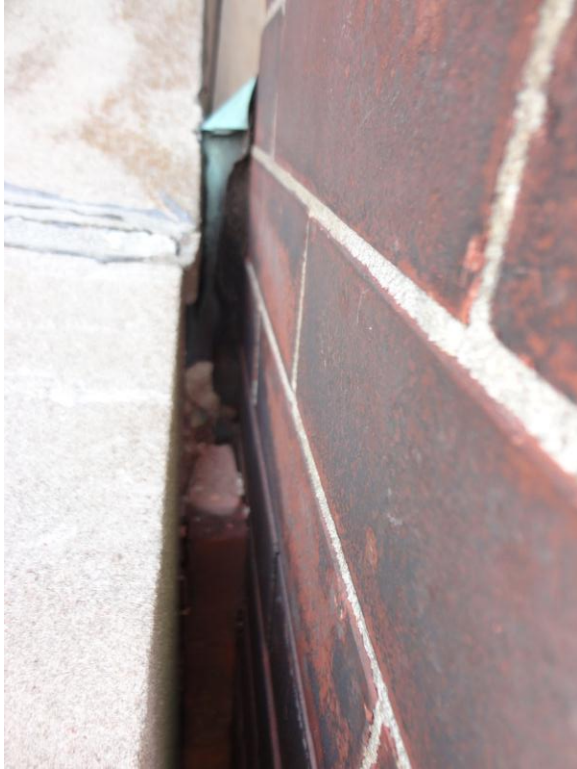
Figure 9. Inappropriate/missing flashing at interface of bell tower and south end of west main gable. Water can freely penetrate into the building here from the gable roof and direct exposure from above.

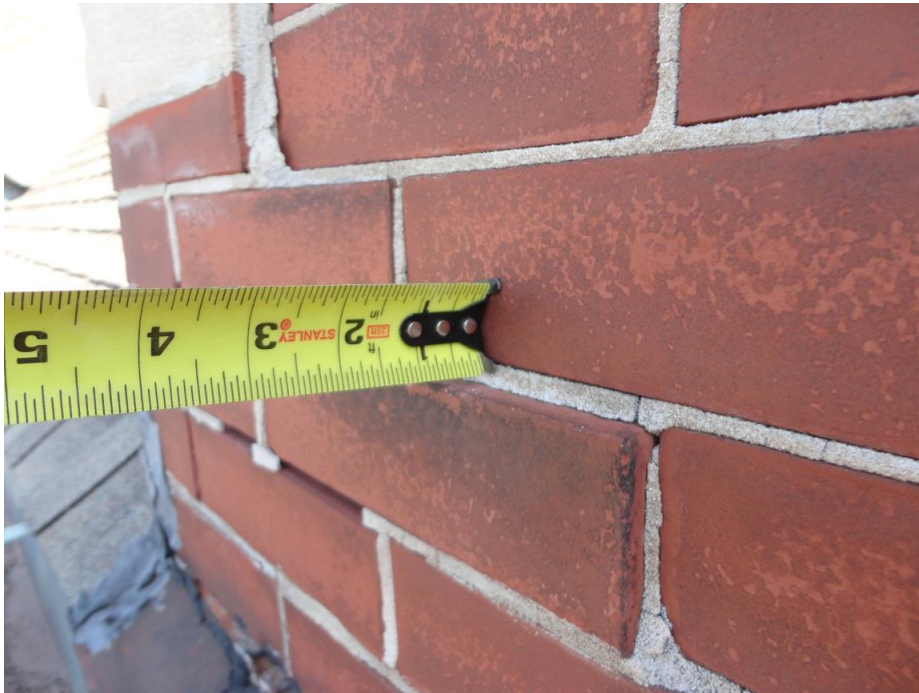
Figure 10. Veneer brick displaced approximately 1/4 inch outward on south elevation middle gable.

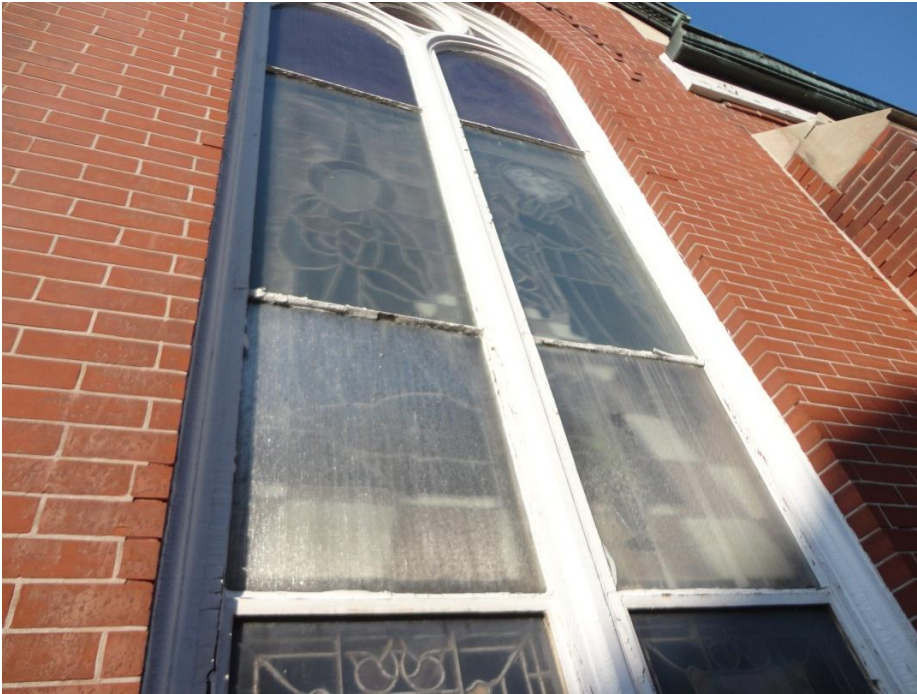
Figure 11. Typical condition of protective glazing at main stained glass windows on north and south elevations.

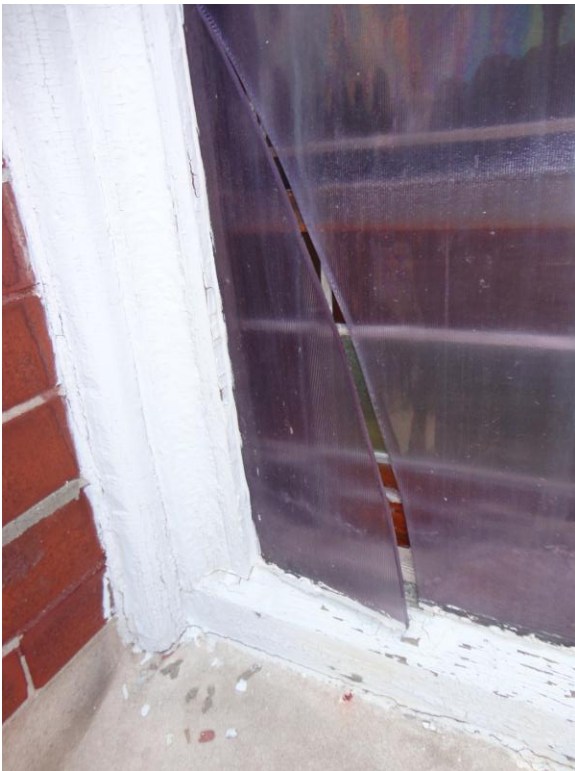
Figure 12. Broken protective glazing at main stained glass window on west face of bell tower.

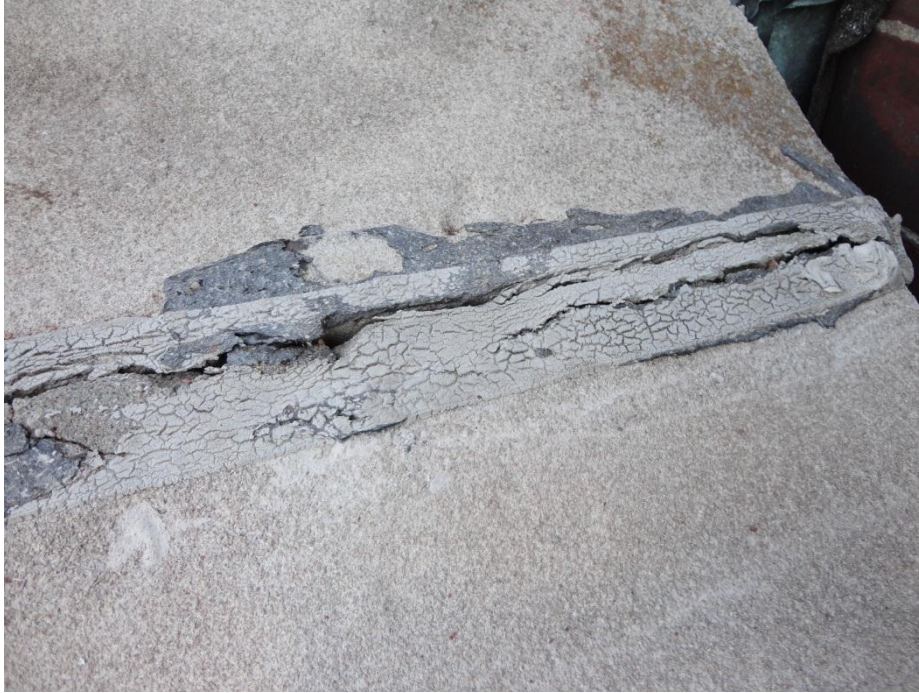
Figure 13. Failed sealant along joint in limestone coping on west main gable showing patterned cracking induced by ultra-violet exposure.

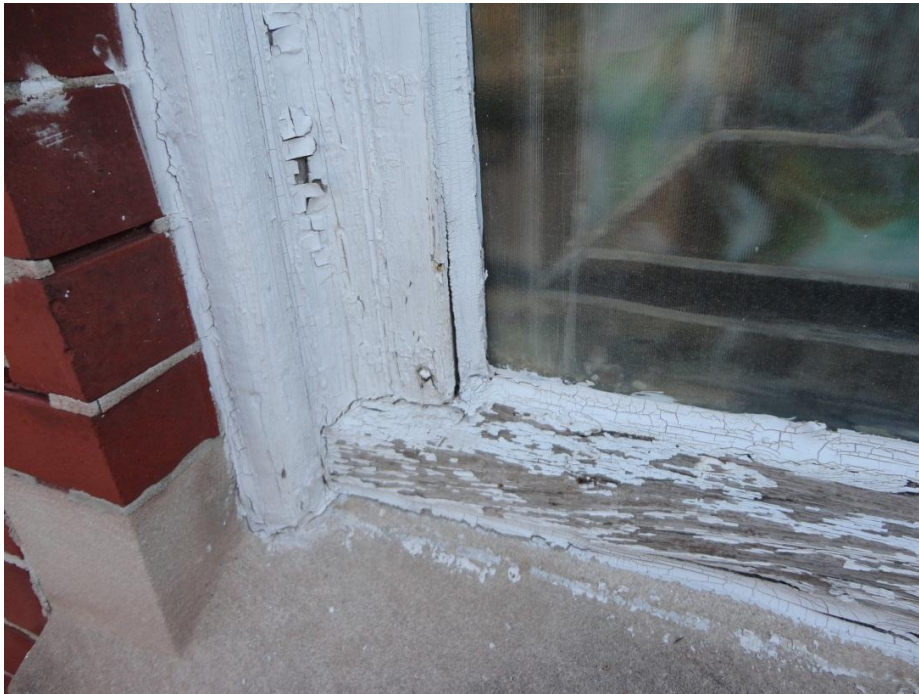
Figure 14. Peeling and missing paint coating at wood window framing.

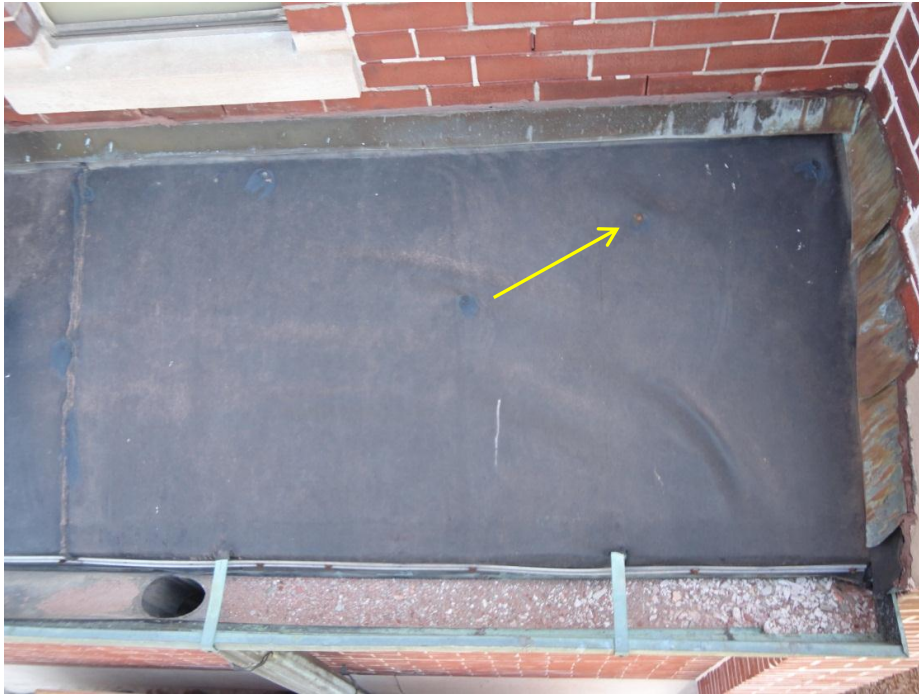
Figure 15. Nail penetrating lower roof EPDM membrane (arrow) on south elevation near bell tower. Note also bulging of membrane and masonry debris in gutter away from downspout.

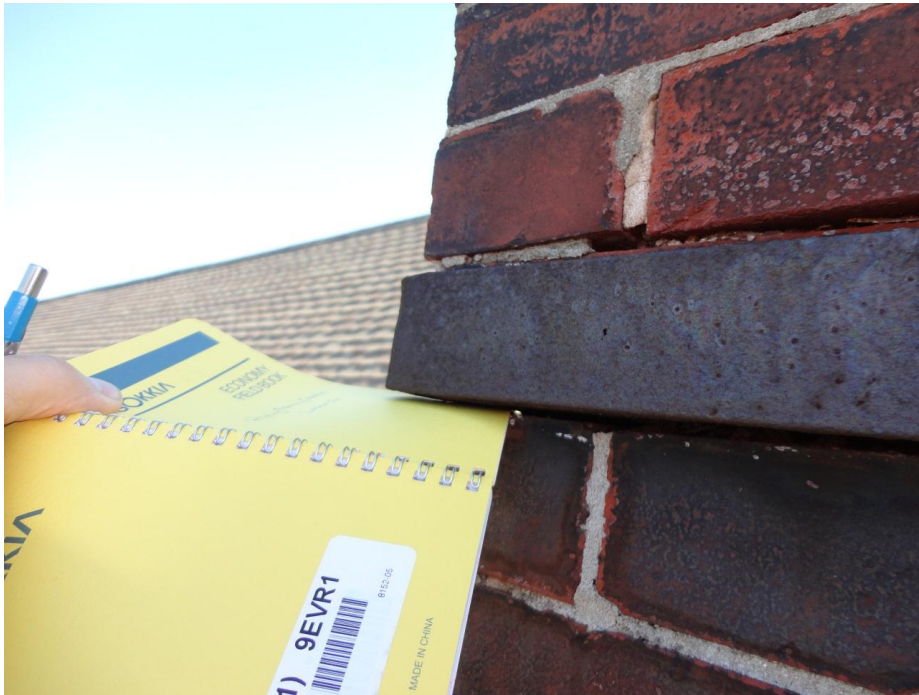
Figure 18. Severe deterioration of chimney mortar joints in vicinity of steel band. Some joints completely missing.

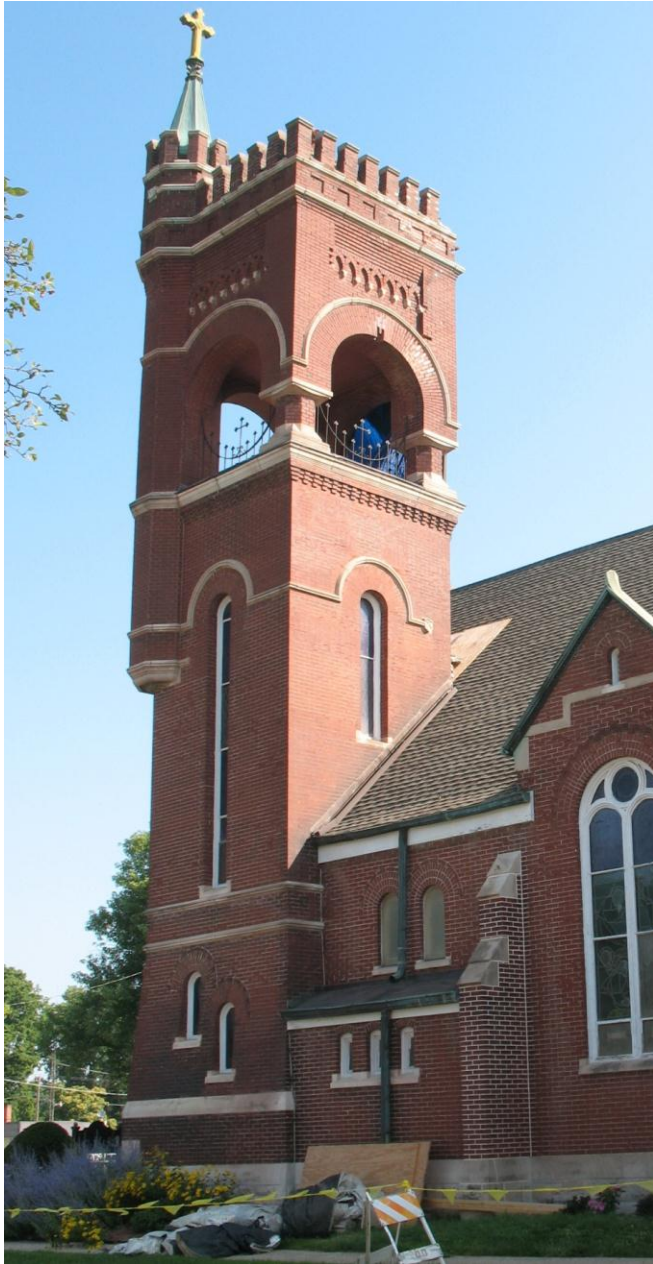
Figure 19. Bell tower as viewed from the southeast.

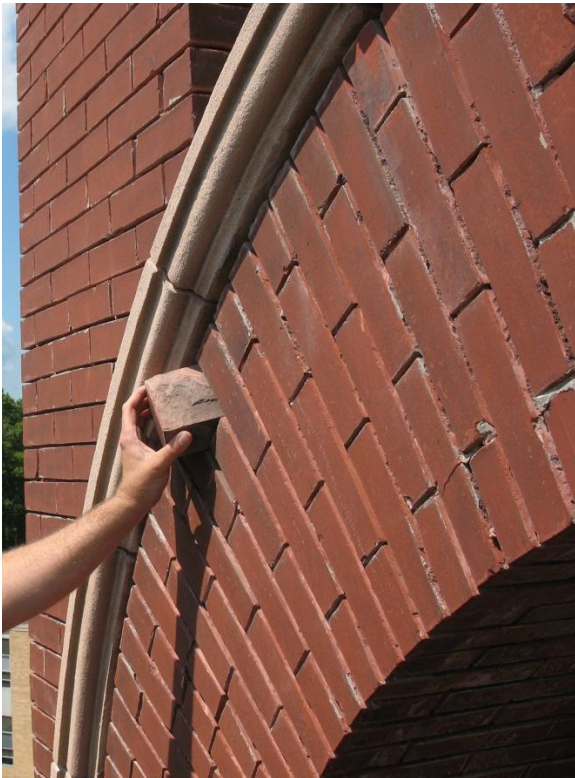
Figure 20. Loose brick removed from tower arch by hand.

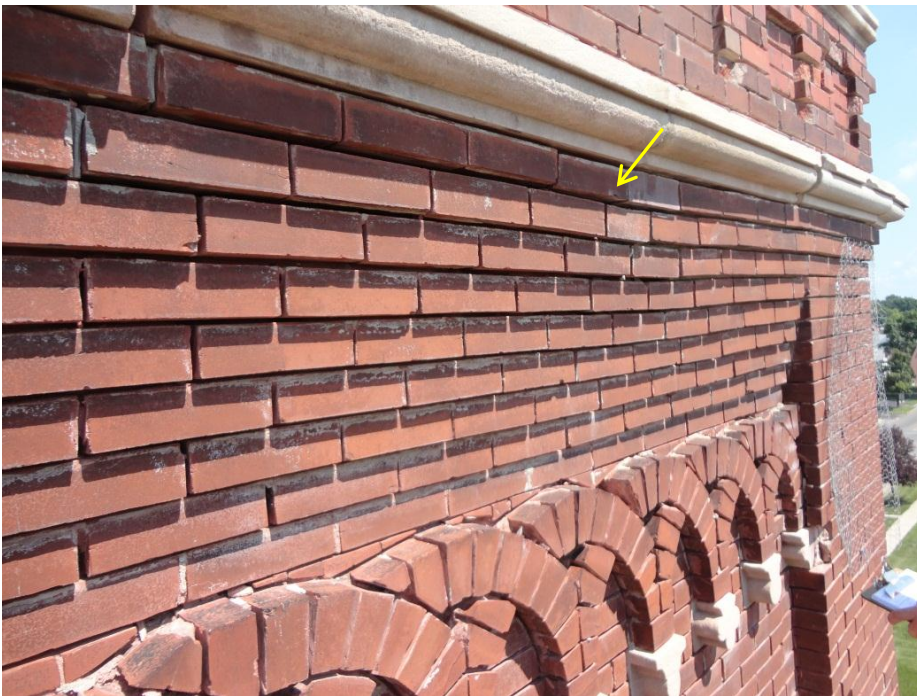
Figure 21. Visible downward displacement (arrow) of recessed courses above main arches on upper bell tower.

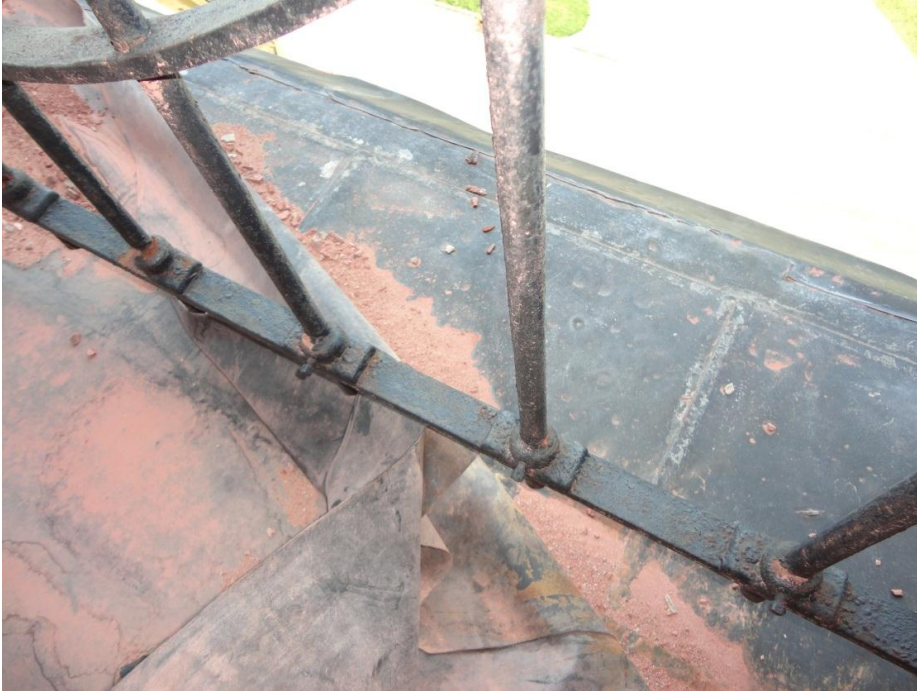
Figure 22. Belfry membrane failed and peeling back from roof edge; underlying original lead-coated copper intact.

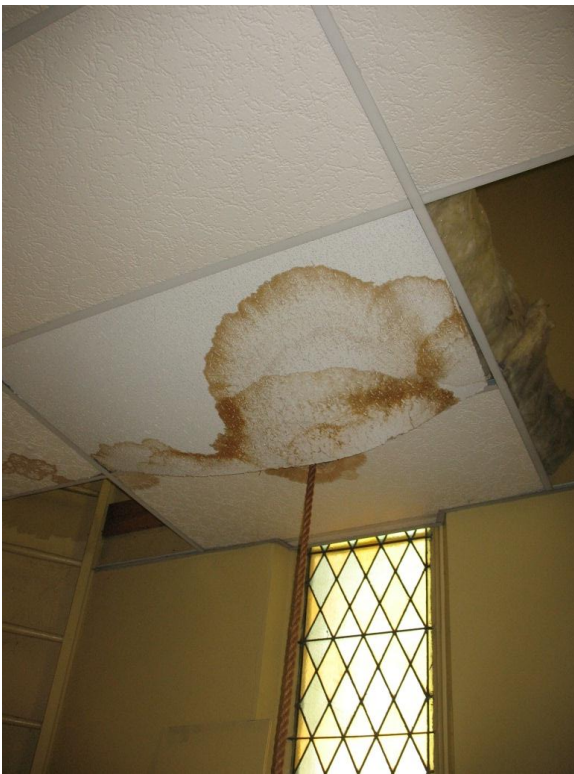
Figure 23. Water damage on drop ceiling of bell tower interior. Note belfry rope hanging through gap in the ceiling.

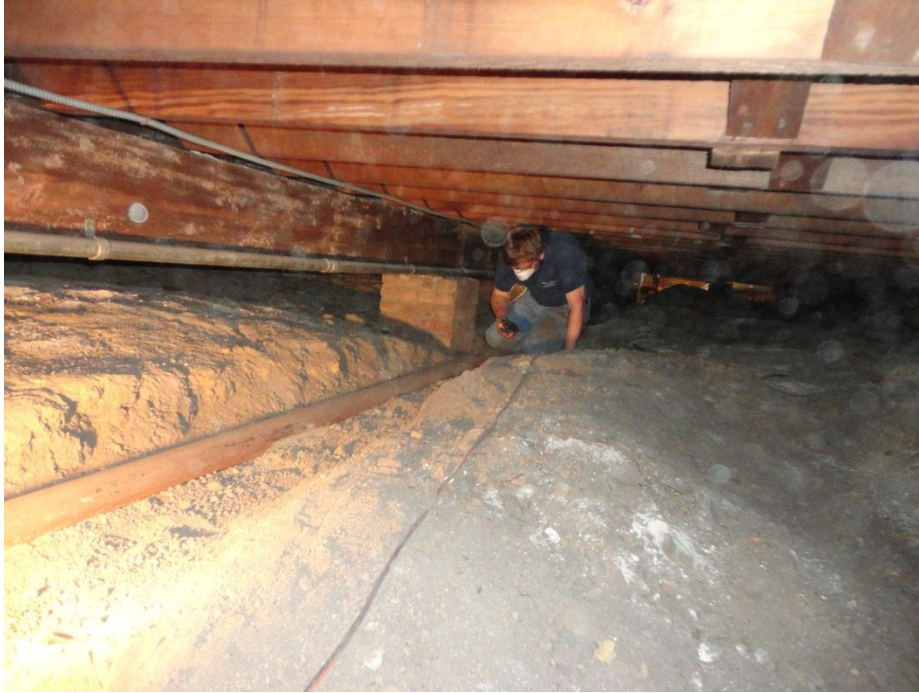
Figure 24. Overall view of joist and beam framing beneath sanctuary.

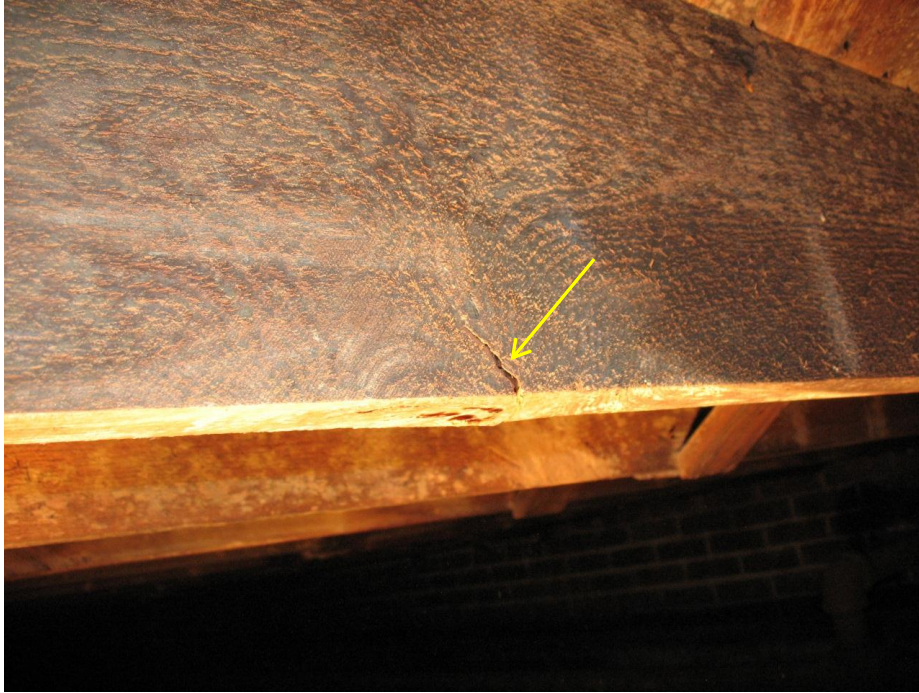
Figure 26. Partial fracture of 2x10 floor joist originating from knot on bottom of member.

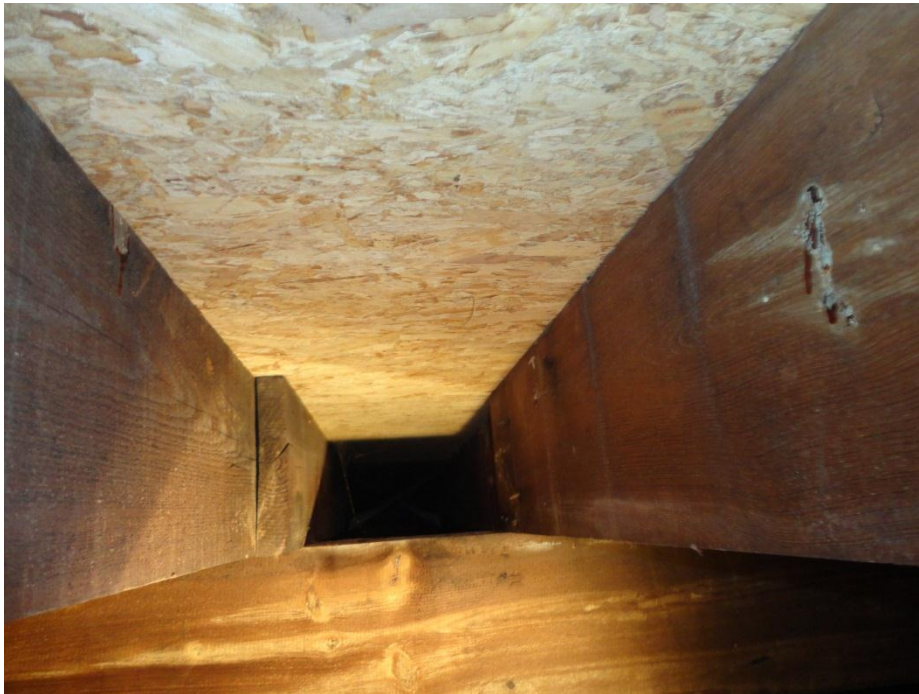
Figure 27. Oriented strand board flooring, north side of sanctuary.

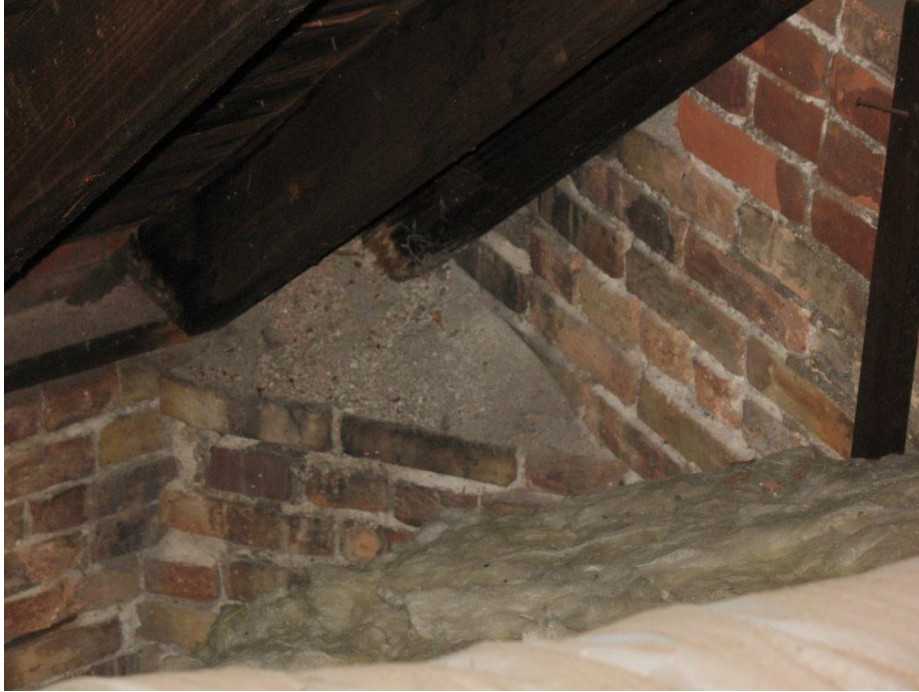
Figure 32. Rafters bearing on wood sill on top of masonry wall near southwest corner. Note light discoloration near bearing location of rafters as possible moisture-related deterioration.

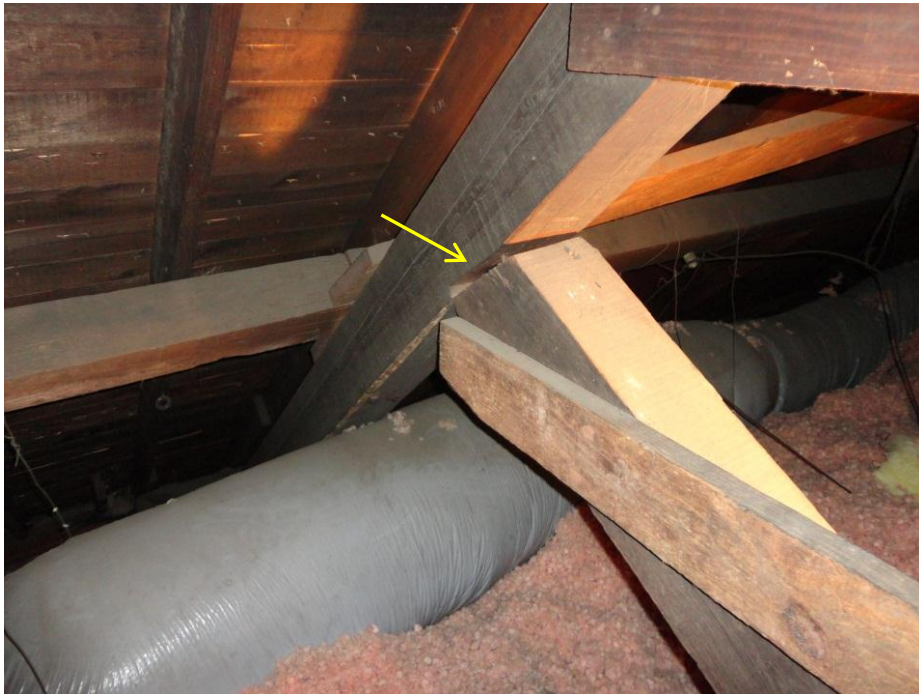
Figure 33. Partial view of north side of first truss from the west wall. Note bottom chord extension nailed to top chord has separated (arrow).

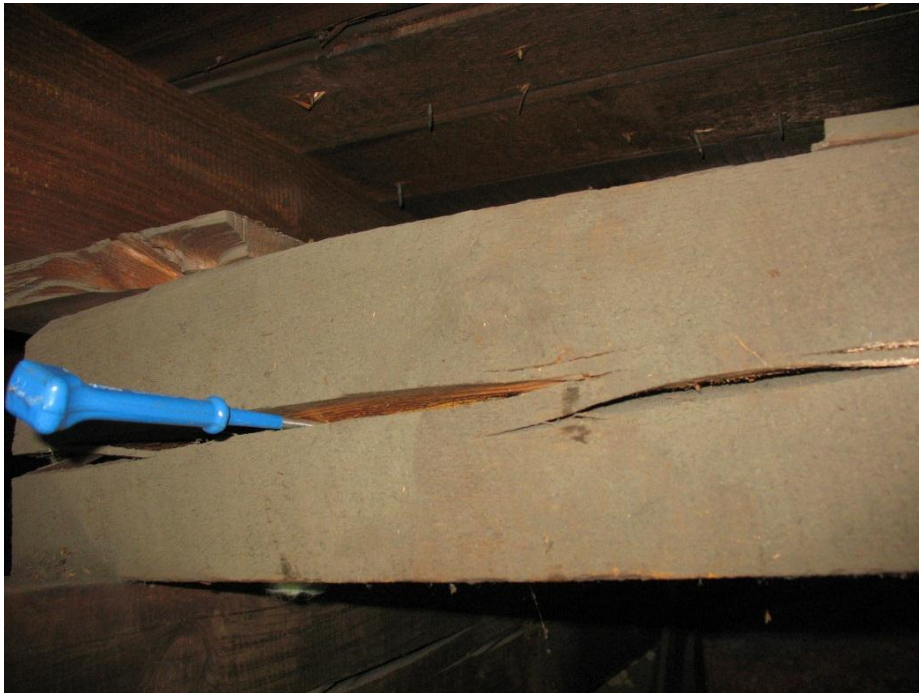
Figure 37. Checking of purlin, approximately 2.5 inches deep. Light coloration within crack may indicate recent formation or growth of this check.

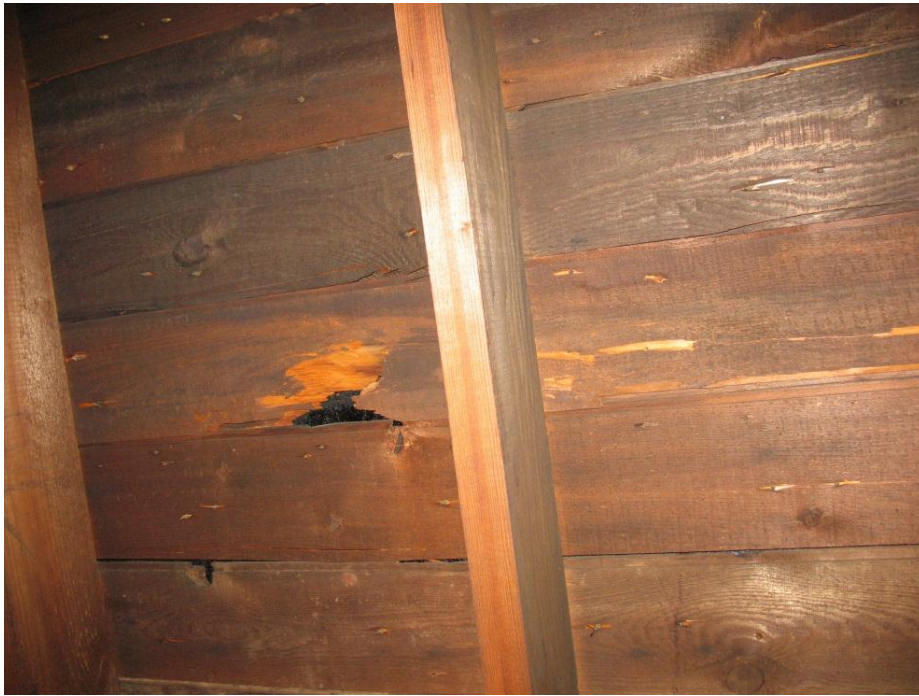
Figure 38. Typical damage to roof decking.

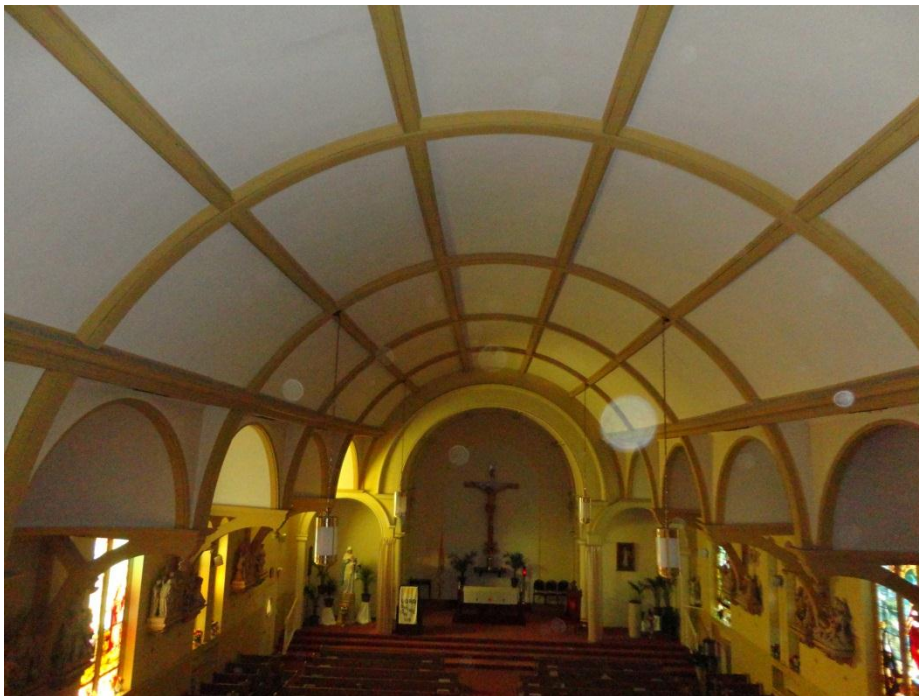
Figure 39. Overall view of church sanctuary.

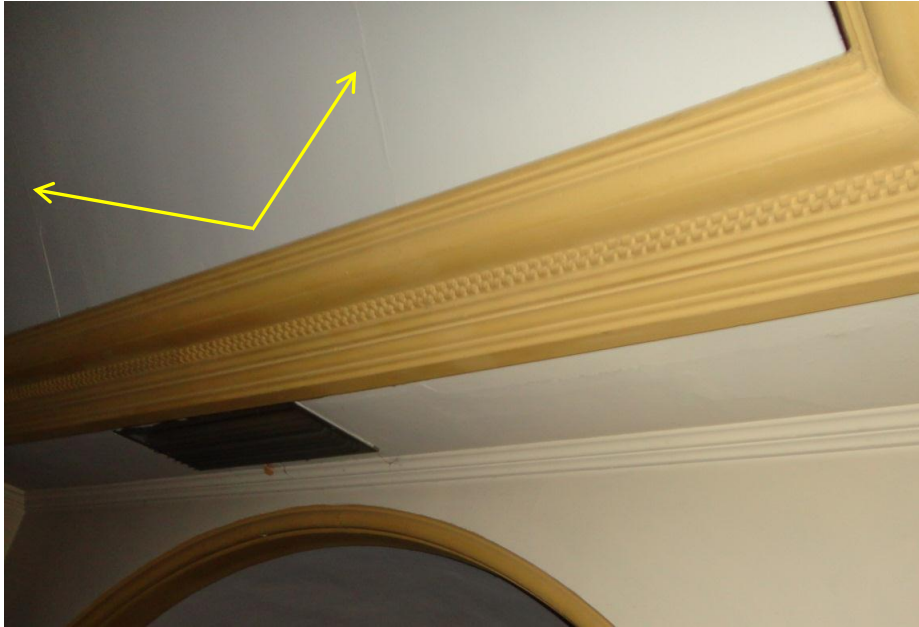
Figure 40. Parallel cracking in plaster skim over plywood panels at barrel vault.

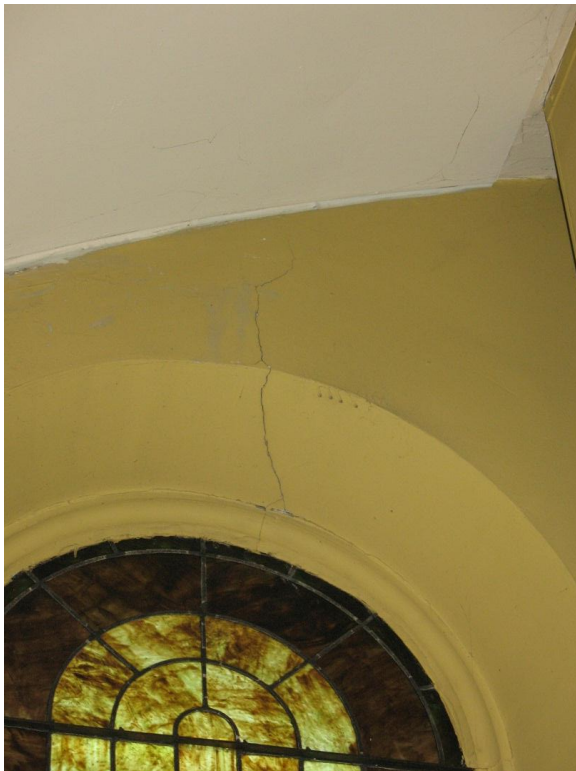
Figure 41. Crack in plaster at south window of west main gable.

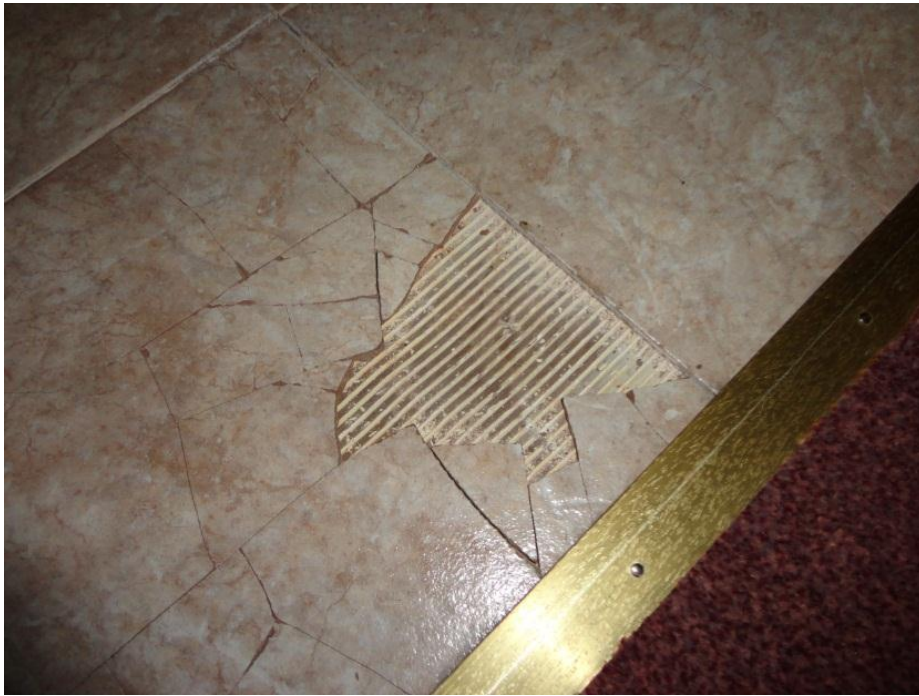
Figure 42. Cracked flooring tile near the information table.

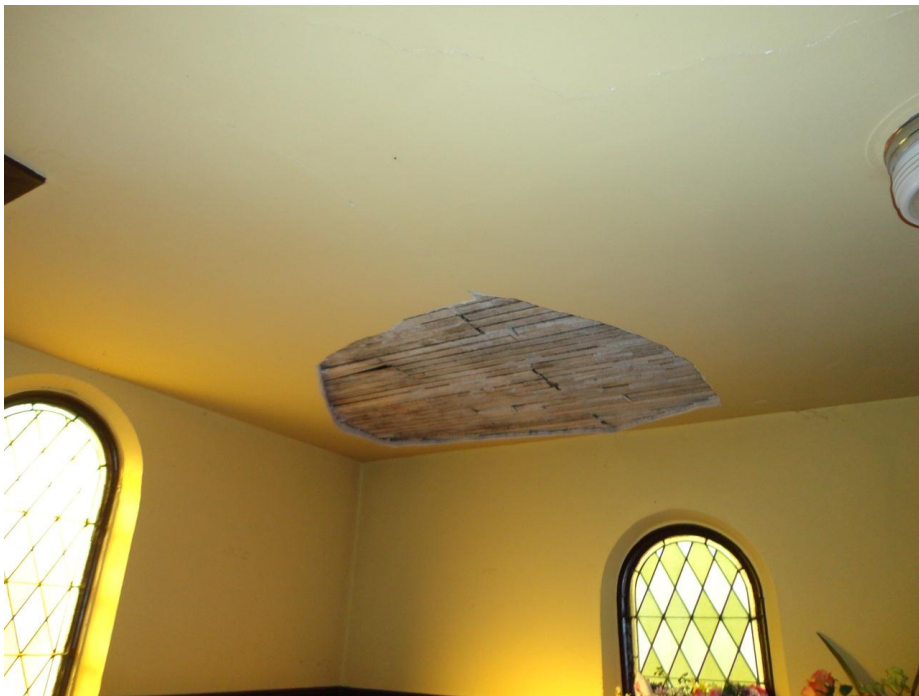
Figure 43. Plaster ceiling failure in southeast sacristy.
